## Keep Looking

BY MIKE VIOLETTE

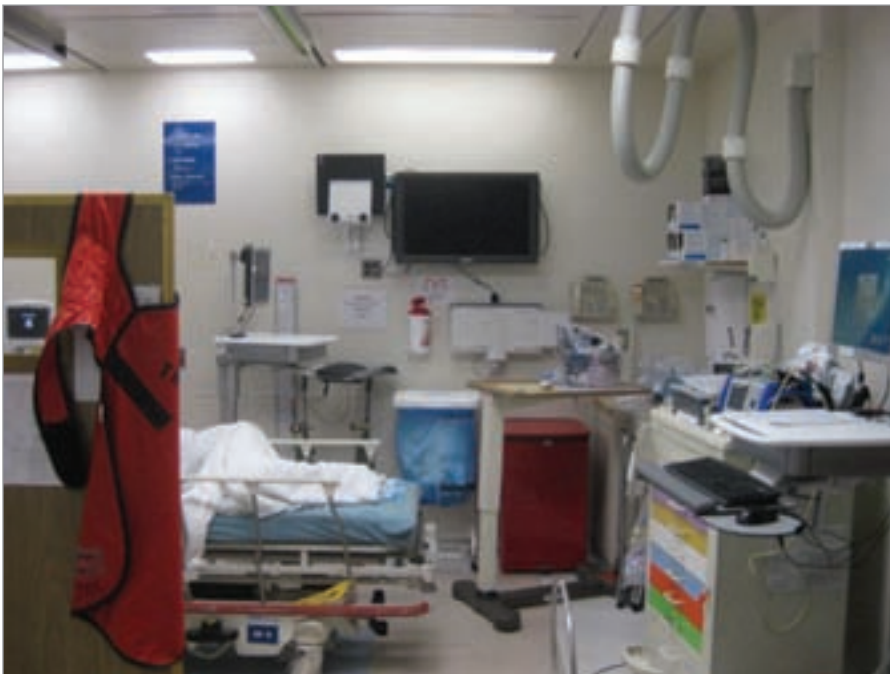
Figure 1: Trauma room

Working in and around the trauma room, for me, was a bit unnerving, what with the gunshot wounds, traffic accidents, mauled limbs and various crises played out in a steady but random order. The trauma room was a critical part of the emergency room function, where triage was performed on the most-acutely injured or suffering. This particular operation featured three beds for quick-action.

An overhead gantry affair allowed the technician to swing the X-Ray source from bed to bed. The key was a quick diagnosis of internal injuries. As the patient may or may not be able to cooperate with the ER team, flexibility in the X-Ray system was of paramount importance. The electronic sensor used a transistor imaging technology in an array-format. When the X-Rays were collected and scanned, the cassette-like sensor (a bit larger than a traditional X-Ray film) wirelessly transmitted the image to the control station and the image could be viewed nearly-instantaneously—no chemicals or delays—pretty cool.

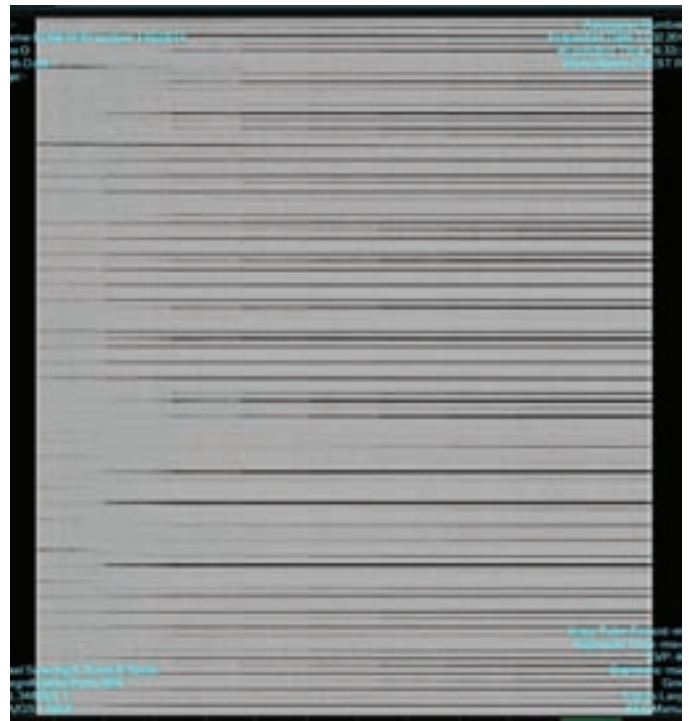
Figure 3: Image with noise artifacts

Figure 2 shows a "clean" image versus a "noisy" image (Figure 3) with the horizontal lines appearing as artifacts. The horizontal lines appear at regular intervals and the (my) initial thought was that the 58kHz was somehow interfering with the rastering of the pixel elements during the imaging process.

The strong periodicity of the artifacts led me to suspect (falsely, it turned out) that the 58 kHz was somehow coupling in the sensor and corrupting the raster scan frequency.

The appearance of the artifacts were definitely correlated to the operation of the RFID. I confirmed the frequency: 13.56 MHz, a standard frequency band.

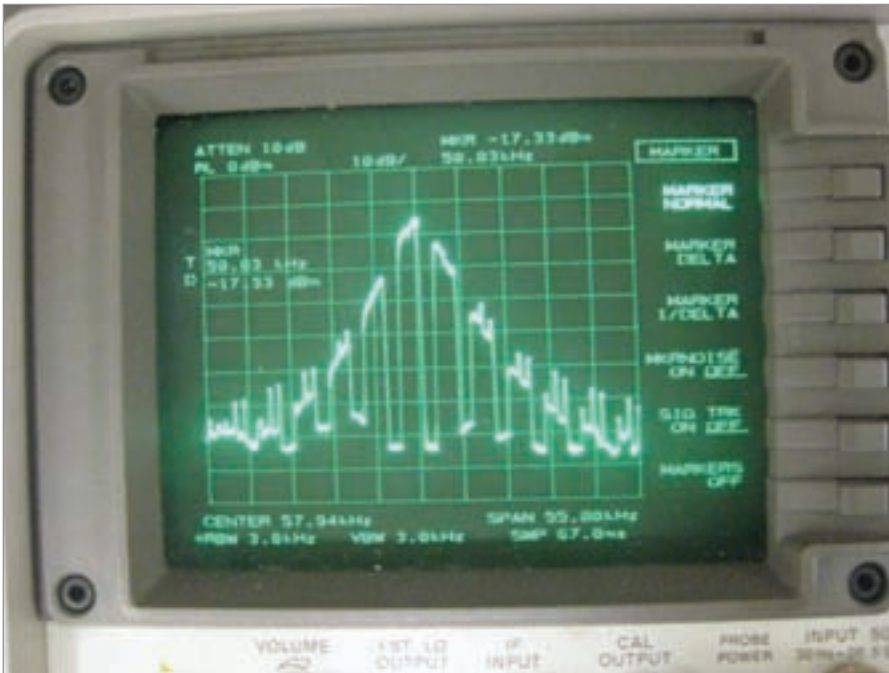
Figure 4: Spectrum of suspected noise

in the proverbial tent was a signal at 58 kHz which had all the hallmarks of a dirty, nasty source (Figure 4, page 18).

The signal had very strong 3<sup>rd</sup> and higher harmonic energies, indicating a fast-switching quasi-square wave behavior. The noise source appeared to be strongly associated with the wiring, cabling, bus duct and even building steel that was on the far-right side of the trauma room.

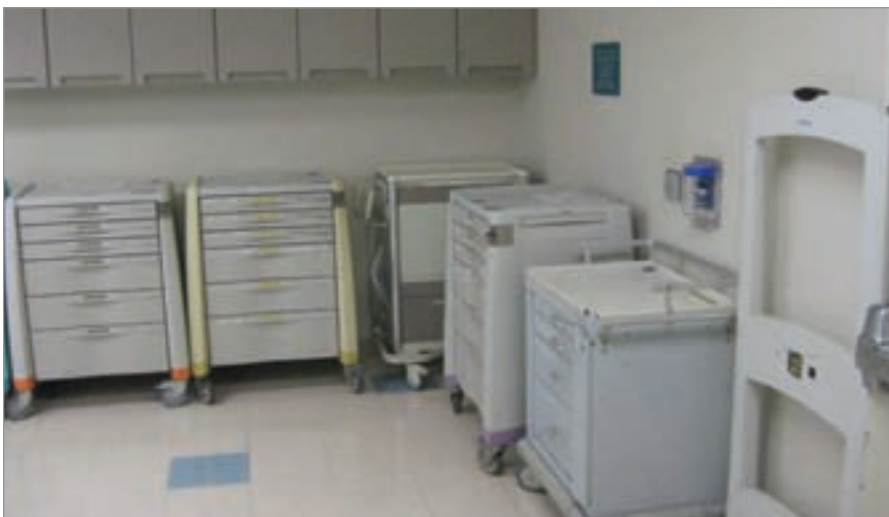
Figure 5: Entrance to ER with RFID pedestal

definitely correlated to the operation of the RFID. I confirmed the frequency: 13.56 MHz, a standard frequency band. The funny thing was, it was not the highest signal level in the general spectrum of noise in the ER. Go figure. We stopped chasing the red herring and gave the more palatable news to the client.

1. This RFID frequency (13.56 MHz) is in very common use and it would not have been evaluated during 60601-1-2 immunity testing for medical equipment as radiated immunity testing is performed from 26 MHz up. In addition, the RFID transmitters use a magnetic field and traditional radiated immunity simulate Electric field sources; the coupling is inherently different. Perhaps the standards community needs to look at doing a “spot frequency” test at the 13.56 MHz frequency?
